Ion™ System Control Version 4.47 Release Notes

This document is provided in conjunction with the “hex” file [BINF0447.hex](#), which comprises the executable code for the following Ion™ System Control model numbers:

- SYST0101CW

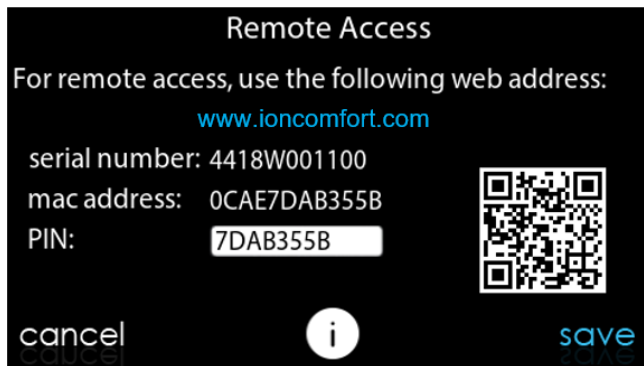
- Added improvements to the GeoHP Windup Control
- For some of the faults the text is trimmed on Home screen

"Fixed the issue of fault text being trimmed in the Fault Message Box. Reset MAX_MSGBOX_LINE_LEN to 14."

- Account registration with mobile app using QR Code on GUI

Displays a QR code on the registration info screen. The QR code contains the S/N number, MAC address, and pin number delimited by commas. The code reflects the current screen values. *Note: This feature requires the new mobile app, available soon.*
